National Defense Center for Energy and Environment

## Corn Hybrid Polymer Media for Coatings Removal from Delicate Substrates

Brian Yallaly, NDCEE

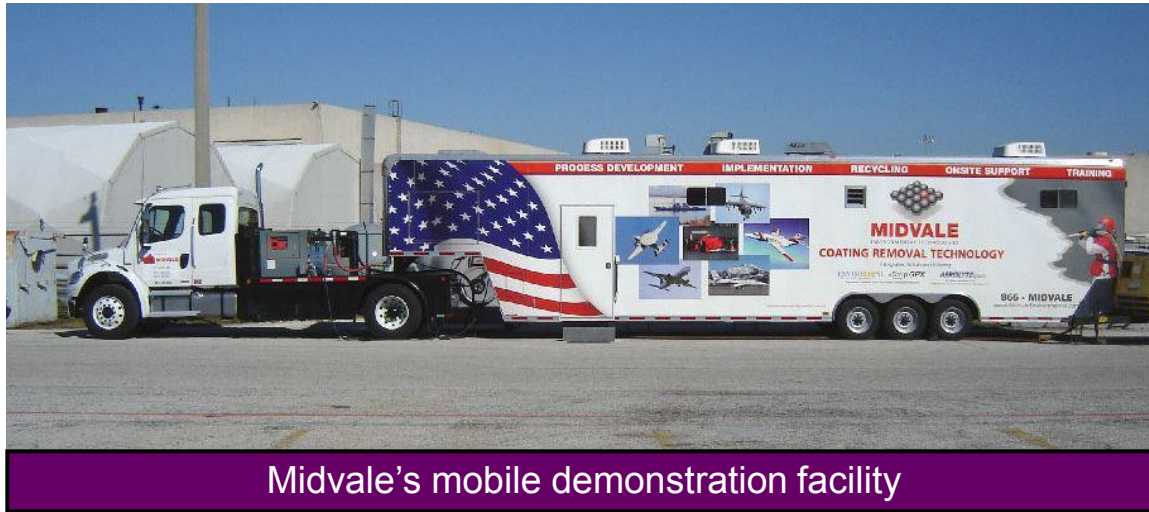
Midvale's mobile demonstration facility

The mobile facility includes a fully enclosed blast room, media delivery system, material recovery system, and personal protective equipment

- Demonstrations were conducted inside of Midvale's mobile demonstration facility, facility blast booths, or in-situ (ship bulkhead)
- Media is recovered inside of the mobile facility and then disposed of by host facility personnel or Midvale

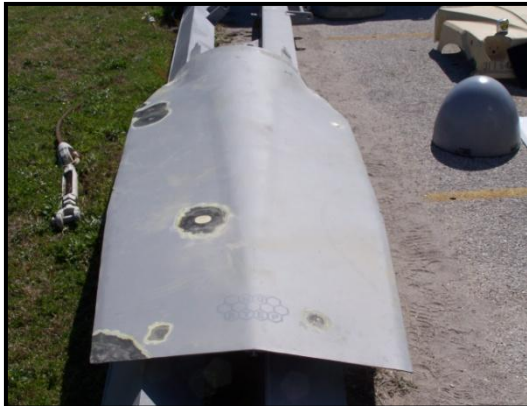
**F-15 speed brake  
(Fiberglass substrate)  
(prior to coating removal)**

- C-130 spinner cap
  - Baseline: 0.6 ft<sup>2</sup>/hr
  - CHP: 9.8 ft<sup>2</sup>/hr
- F-15 speed brake
  - Baseline: 0.3 ft<sup>2</sup>/hr
  - CHP: 9.1 ft<sup>2</sup>/hr
- MK-92 radome panel
  - Baseline: 4.0 ft<sup>2</sup>/hr
  - CHP: 29.7 ft<sup>2</sup>/hr
- P-3 radome panel
  - Baseline: 3.0 ft<sup>2</sup>/hr
  - CHP: 12.3 ft<sup>2</sup>/hr
- SH-60 helicopter blade
  - Baseline: 1.0 ft<sup>2</sup>/hr
  - CHP: 9.0 ft<sup>2</sup>/hr
- HMMWV hood
- PCMS tiles
- NASA windbrake panels
- T-45 speed brake
- EP-3 blade antenna
- F-18 antenna cover
- Surface ship life raft shell
- LM2500 gas turbine engine bullet nose
- Locker shield
- AS2815 UHF antenna

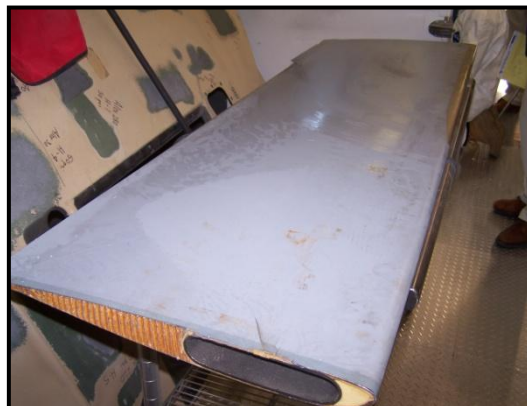
**SH-60 helicopter blade  
(Titanium/fiberglass/carbon graphite  
substrate)  
(prior to coating removal)**

<b>SH-60 Helicopter Blade</b>	Polyurethane	Titanium, fiberglass, and carbon graphite matrix	Hand Sanding	1.0	Fiber waste is not contained and sanding process is not worker friendly	26	29.0	Coating removed to primer with no visible substrate damage
						35	9.0	Coating removed to substrate with no visible damage
<b>MK-92 Radome</b>	Enamel (7-9 mils)	Honeycomb fiberglass	Hand Sanding	4.0	Extremely time consuming and labor intensive	37	29.7	Topcoat and 50% of first primer removed with no visible substrate damage
						37	32.1	Coating removed to primer on majority of area and selectively removed to the substrate in one small area

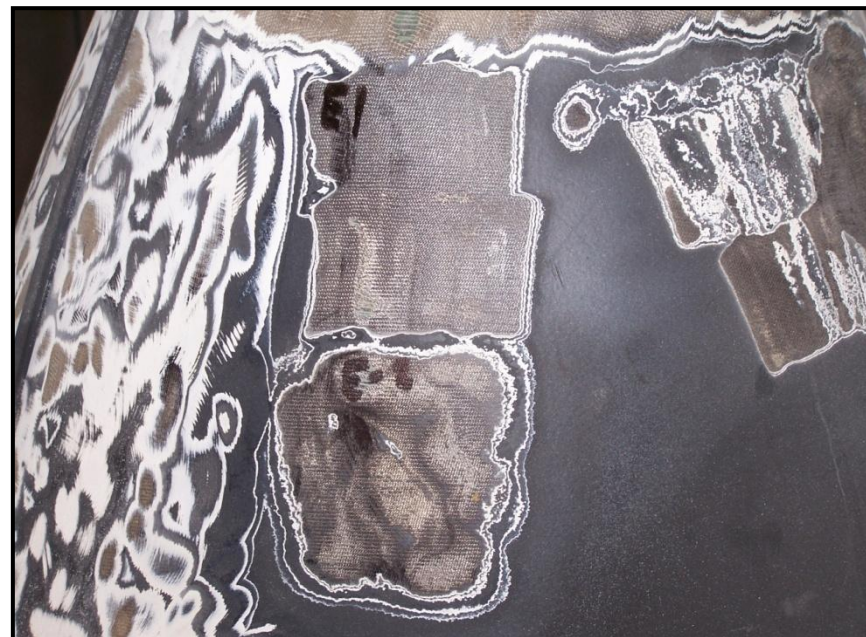
Coating removed from C-130 spinner cap at a rate of 10 ft<sup>2</sup>/hr with no visual damage to the substrate (fiberglass) or embedded electrical wires

Component	Coating System	Substrate	BASELINE PROCESS			CHP		
			Process	Strip rate (ft <sup>2</sup> /hr)	Comments	Nozzle Pressure (psi)	Strip rate (ft <sup>2</sup> /hr)	Observations
<b>C-130 Spinner</b>	Surface primer with polyurethane erosion resistant coating (7-9 mils total)	Fiberglass with electrical wires embedded	Hand Sanding	0.6	Significant damage to substrates and wires embedded within	35	9.8	Coating removed to the substrate with no visible damage
<b>F-15 Speed Brake</b>	Wash Primer, followed by polyurethane, finished with antistatic topcoat (15 mils total)	Fiberglass	Hand Sanding	0.3	Extremely time consuming and substrate damage often noted	33	9.1	Coatings removed to primer with no visible substrate damage
<b>P-3 Radome</b>	Epoxy primer and polyurethane topcoat (10 mils total)	Polyester fiberglass	Hand Sanding	3.0	Extremely time consuming and substrate damage often noted	23	12.3	100% removal of topcoat and primer with no visible substrate damage

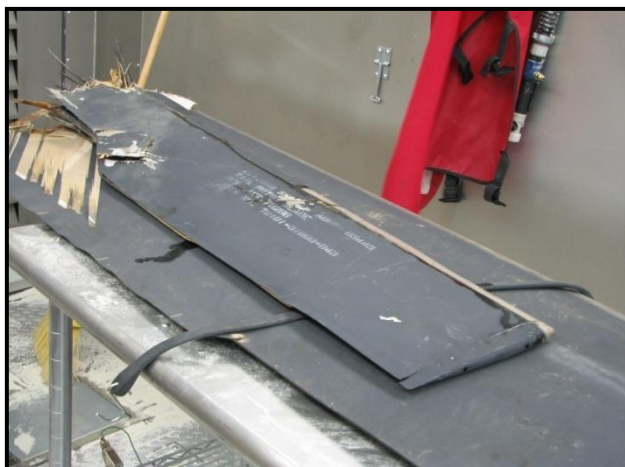
UH-60 rotor blade  
(Fiberglass substrate with sections of  
aluminum lightning mesh)  
(prior to coating removal)

- UH-60 Rotor Blade (Kevlar)
  - CHP: 34.4 ft<sup>2</sup>/hr
- OH-58 Radio Compartment Door (aluminum)
  - CHP: 24.3 ft<sup>2</sup>/hr
- OH-58 Pilot Door (aluminum)
  - CHP: 12.9 ft<sup>2</sup>/hr
- UH-1H Tail Rotor Blade (honeycomb aluminum)
  - CHP: 17.7 ft<sup>2</sup>/hr (to primer), 8.7 ft<sup>2</sup>/hr (to substrate)
- UH-1H Elevator Skin (aluminum)
  - CHP: 23.1 ft<sup>2</sup>/hr
- UH-1H Transmission Mount (cast iron)
  - CHP: 37.5 ft<sup>2</sup>/hr
- OH-58 Cowling Cover (fiberglass)
  - Removal rate not determined

Component	Substrate	Baseline Process	CHP		
			Nozzle Pressure (psi)	Strip rate (ft <sup>2</sup> /hr)	Observations
<b>UH-60 Rotor Blade</b>	Kevlar with Section of Aluminum Lightning Mesh	Hand Sanding	32	<b>34.4</b>	Coating removed completely to substrates (i.e., Kevlar and aluminum) with no visual substrate damage
<b>OH-58 Radio Compartment Door</b>	Aluminum	Chemical Stripping/Hand Sanding	35	<b>24.3</b>	Topcoat and the majority of the primer removed with no visible damage to the underlying substrate
<b>OH-58 Pilot Door</b>	Aluminum	Chemical Stripping/Hand Sanding	35	<b>12.9</b>	Topcoat and the majority of the primer removed with no visible damage to the underlying substrate
<b>UH-1H Tail Rotor Blade</b>	Honeycomb Aluminum	Chemical Stripping/Hand Sanding	30	<b>17.7</b>	Coatings removed to the primer with no visual damage to the underlying substrate
			35	<b>8.7</b>	80% of the primer removed with no visual damage to the underlying substrate

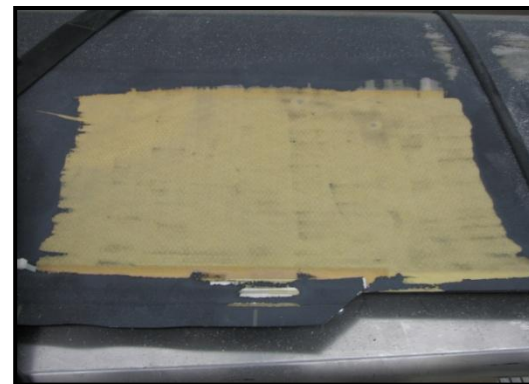
Coatings removed to fiberglass  
substrate at a rate of 34.4 ft<sup>2</sup>/hr (@  
32psi) with no substrate damage

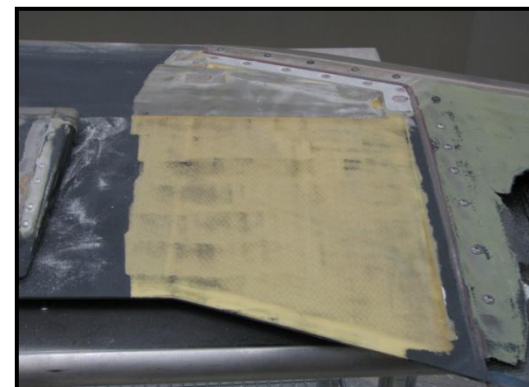
Coatings removed from fiberglass  
as well as a section of aluminum  
lightning mesh

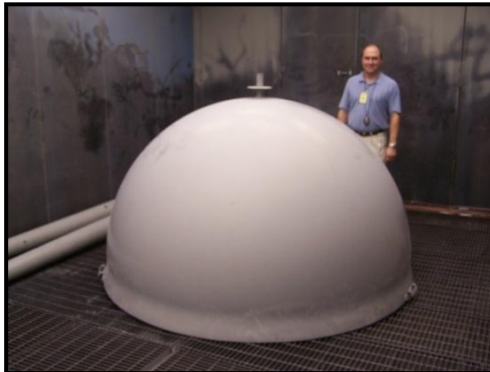
MK-92 Radome in SERMC  
Antenna Repair Blast Booth

- Surface Area: 250 ft<sup>2</sup>
- Baseline hand sanding: 4 ft<sup>2</sup>/hr = 62.5 hrs/part
- CHP: 36 ft<sup>2</sup>/hr (@25psi) = 7 hrs/part
- Labor savings: 55.5 hrs/part

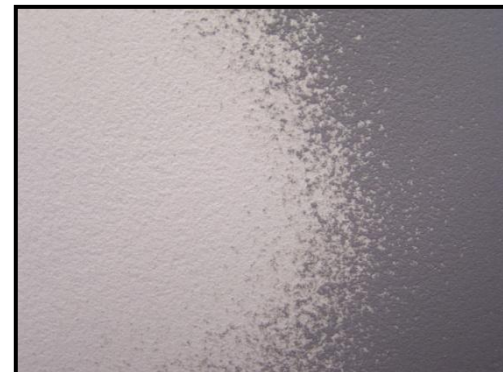
MK-92 Radome Close-up of  
Blasted Area

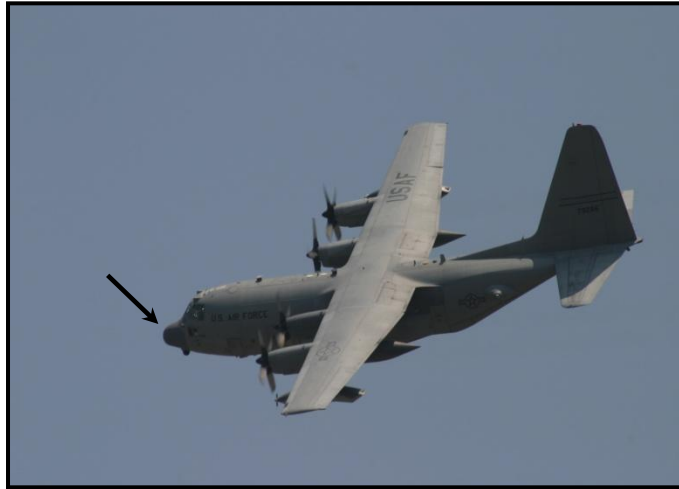
# MC-130H Nose Radome

- Fiberglass Honeycomb Substrate
- Coating System:
  - MIL-PRF-23377 Type 1 Primer
  - MIL-C-83231 Type II Polyurethane Rain Erosion Coating
  - MIL-C-85285 Polyurethane Topcoat
- Strip Rate 42.35 ft<sup>2</sup>/hr (@35psi)
- Coating removed to bare fiberglass substrate
- No visible substrate damage

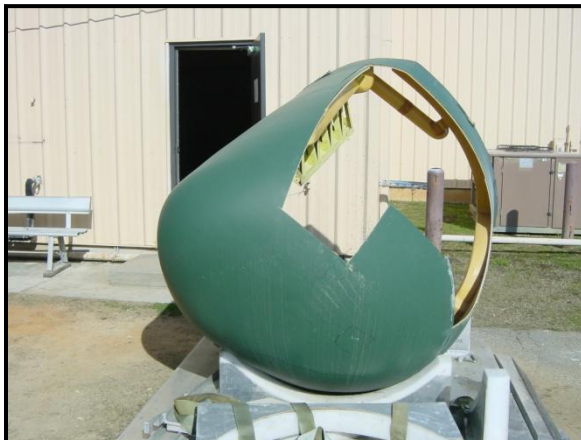
Scrap MC-130 Nose Radome for Demonstration

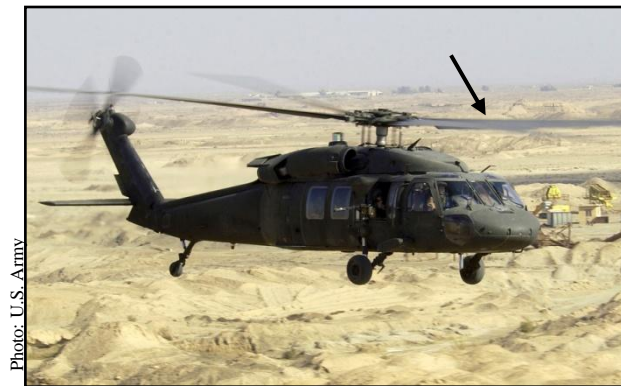
# UH-60 Blackhawk Rotor Blade

- Fiberglass Honeycomb Substrate with Aluminum Lightning Mesh
- Coating System:
  - MIL-PRF-23377 Primer
  - MIL-C-46168 Topcoat
- Strip Rate 15.3 ft<sup>2</sup>/hr (@30psi) (Baseline: 1.5 ft<sup>2</sup>/hr)
- Coating removed to bare fiberglass substrate
- No visible substrate damage

Component	Substrate	Baseline Process	CHP		
			Nozzle Pressure (psi)	Strip rate (ft <sup>2</sup> /hr)	Observations
<b>UH-60 Blackhawk Main Rotor Blade</b>	Titanium and fiberglass with lightning mesh covering portions of fiberglass	Hand Sanding	30	<b>15.3</b>	Coating and primer removed
<b>UH-60 Blackhawk Tip Cap</b>	Graphite composite with nickel abrasion strip on edge. Portions covered with copper and stainless steel mesh.	Hand Sanding	25	<b>33.5</b>	Coating removed to primer
<b>UH-60 Blackhawk Tail Rotor Blade</b>	Fiberglass with aluminum lightning mess covering entire surface	Hand Sanding	30	<b>23.5</b>	Coating removed to lightning mesh
<b>UH-60 Blackhawk Stabilator</b>	Aluminum and Kevlar sections	Al: PMB Kevlar: Hand Sanding	Al: 25 Kevlar: 30	Al: 32.1 Kevlar: 15.1	Coating and primer removed

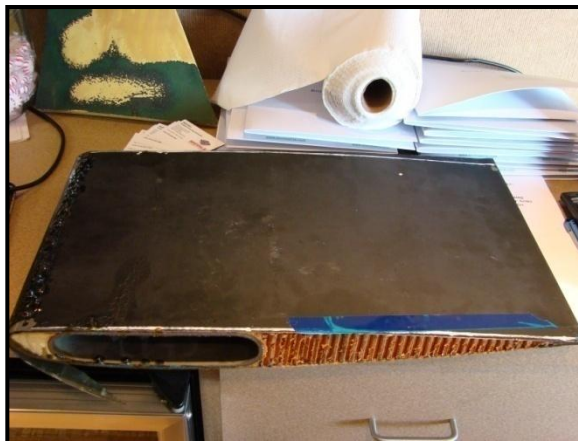
UH-60 Rotor Blade Section  
Prior to CHP Blasting

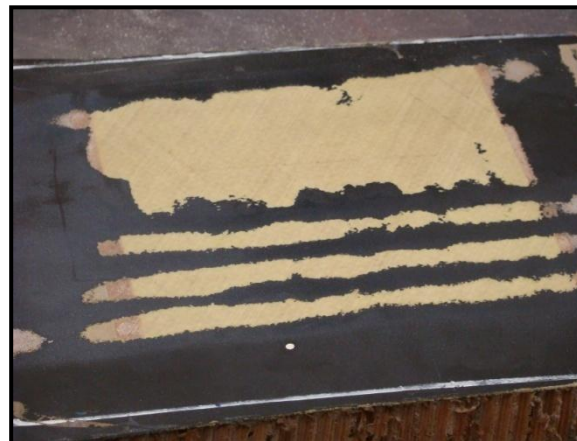
UH-60 Rotor Blade Section  
CHP Blasting Various Pressures

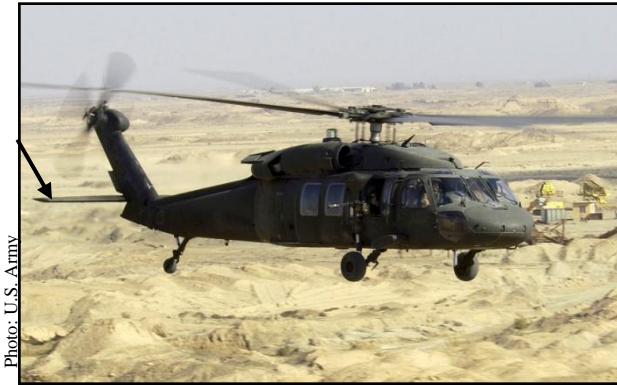
# UH-60 Blackhawk Stabilator

- Aluminum and Kevlar Substrates
- Coating System:
  - MIL-PRF-23377 Primer
  - MIL-C-46168 Topcoat
- Strip Rate: Aluminum Section: 32.1 ft<sup>2</sup>/hr (@25psi)  
(Baseline: 34.5 ft<sup>2</sup>/hr)  
Kevlar Section: 15.1 ft<sup>2</sup>/hr (@32psi)  
(Baseline: 2.05 ft<sup>2</sup>/hr)
- Coating removed to bare substrates
- No visible substrate damage

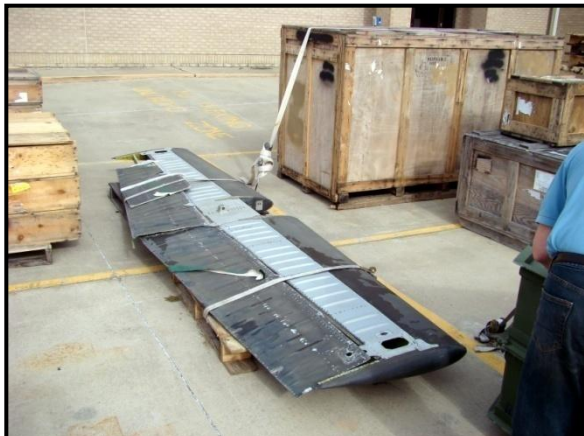
UH-60 Blackhawk Stabilator Prior to  
CHP Blasting
